GYP SUM PLANT SCREW CONVEYOR TROUGH INSPECTION DOOR

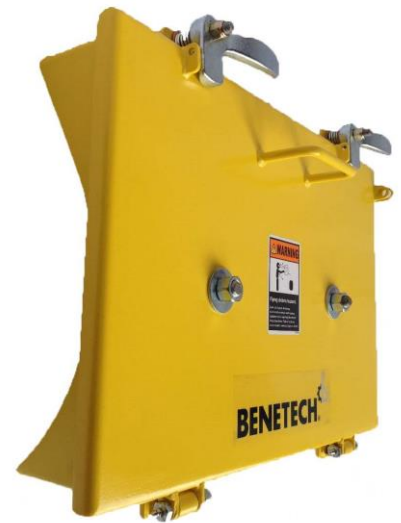
BEFORE

A North American gypsum plant was experiencing increased maintenance and housekeeping costs due to an access door on their screw conveyor that was flat and bolted-on. Opening and closing the access door was a very long and taxing process due to the fact that each bolt had to be individually screwed on and off. Additionally, this process would result in stripped bolt threads and the aggravating task of replacing bolts. Excess leakage was experienced because the bolted on doors failed to provide a dust-tight seal. The flat door also had a ledge that collected material which fell to the floor every time it was opened.

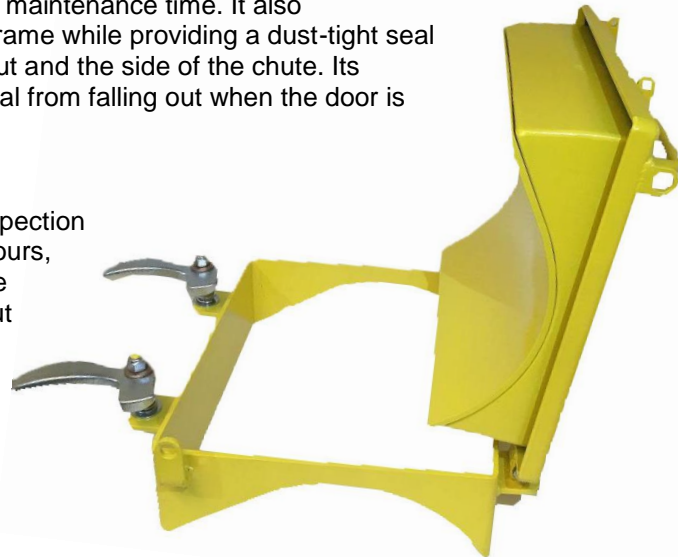
Benetech utilized its experience with inspection doors to create a customized solution that ensures both proper servicing of components and efficient housekeeping that helps control build-up. Simple to install, open and close, the bolt-free Screw Conveyor Curved Access Door allows quick and easy access for clean-out, inspection and repair with notably less maintenance time. It also reduces dust accumulation on the door and the frame while providing a dust-tight seal that stops material leakage from the access cutout and the side of the chute. Its curvature to the conveyor further prevents material from falling out when the door is opened.

The plant is extremely happy with the results. Inspection and maintenance times have been reduced by hours, and the door's bolt-free design has eliminated the spillage issues the plant was having. Cleaning out the screw conveyor trough is no longer an aggravating task.
